# PEMBeyond

**PEMFC system and low-grade bioethanol processor unit development for back-up and off-grid power applications**

**Deliverable 6.5**

**HAZOP report**

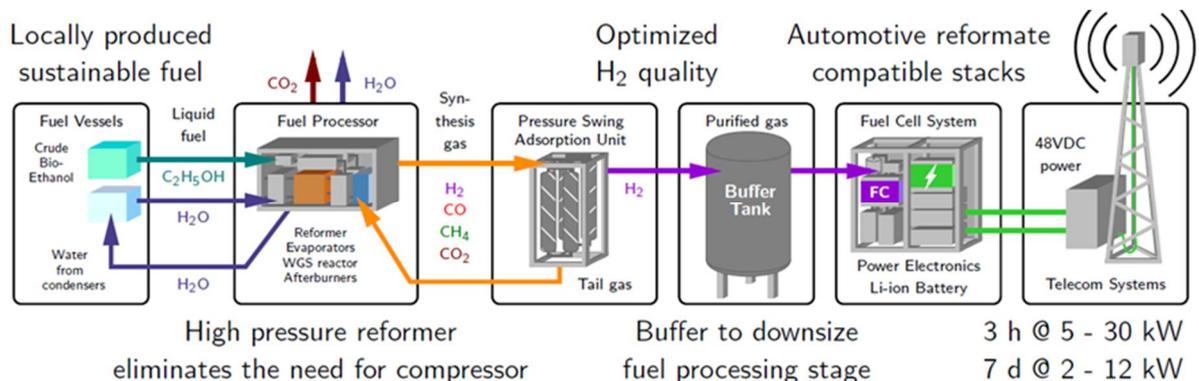
Fig. 1. The system concept showing the flow of fuel (bioethanol & water) through fuel processing and purification, finally entering the fuel cell system. (Koski et al. 2016)

This Deliverable deals with the **Hazard** and **Operability** study (HAZOP) of the integrated PEMFC based power system operating on low-grade (crude) bioethanol that is developed in [PEMBeyond](#) project. The system is intended for back-up and off-grid power generation and it uses crude bioethanol as primary fuel to produce electricity (see Fig.1). The system consists of the following four main subsystems (Koski et al. 2016):
